Rockwell Specific Plan Historical Evaluation

January 2010

Prepared by
Johnson Architecture
942 East Olive Avenue
Fresno, CA 93721

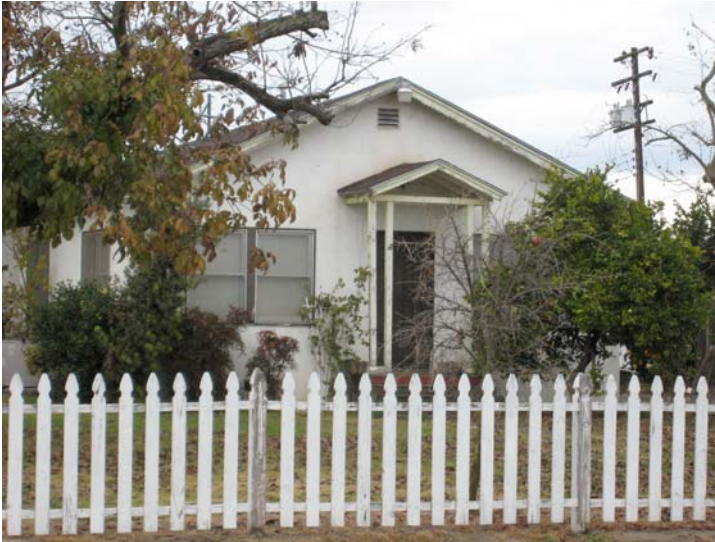
8168 East Floral Avenue. Photo courtesy of Johnson Architecture, December 2009.

This residence is located at the southwest corner of East Floral Avenue and De Wolf Avenue. The single-family residence located at 8685 East Floral Avenue was constructed in approximately 1940. This single-story structure has a rectangular footprint has a gable roof sheathed in composite shingles, with wide eaves and exposed rafter tails. A dropped, secondary, gable roof is located on the south primary elevation, and marks the projecting entrance porch. The exterior walls are clad in stucco. The current stucco is a later addition, indicated by its spray application finish. The buildings fenestration pattern includes: single and paired wood frame, double-hung, sash windows. A brick chimney is located at the far north end of the building.

The principal residential entry is centrally located on the south elevation. The doorway is accessed by a concrete step. The entryway is a wood door with aluminum-frame screen.

A paired, wood-frame, double-hung sash window is located west of the entry. A single, wood-frame, double-hung sash punctuates the east side of the south elevation.

At the time of the site visit, visibility of the west elevation was obstructed by plant growth. The visible windows that punctuate the elevation are comprised of two sets of paired, wood-frame, double-hung sash windows.

The east elevation is divided into two bays. The northeast corner projects from the building and has two sets of paired, wood-frame, double-hung sash on the east end. A single, wood-frame, double-hung sash punctuates the north and south end of the projecting bay. A series of single and paired wood-frame, double-hung sash windows, and one aluminum frame pop-out window punctuate the remainder of the elevation.

A separate two-car garage with attached shed occupies the rear northeast corner of the lot. The wood-frame structure has a gabled roof covered with corrugated metal. Exterior walls are sheathed in drop siding. The garage doors are metal. A wood panel door punctuates the shed on the far west end of the structure.

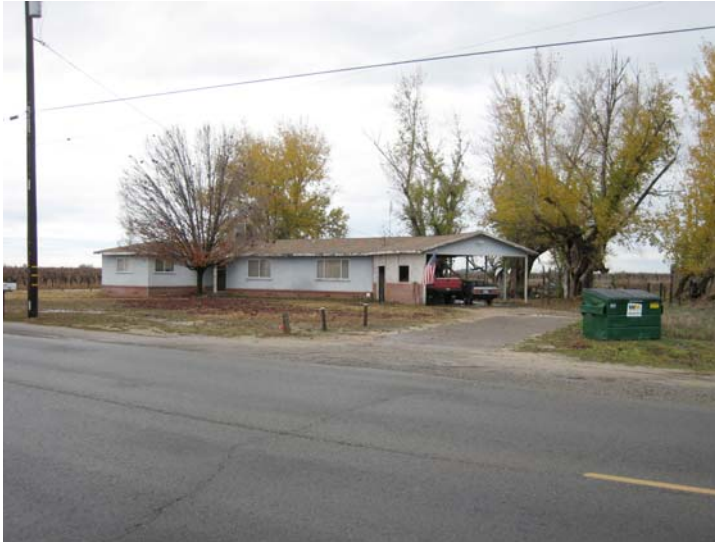
8382 East Floral Avenue. Photo courtesy of Johnson Architecture, December 2009.

The residence at 8382 East Floral Avenue is an example of the Ranch housing type. The residence was built in approximately 1965, and does not qualify as a historic resource, as it is less than 50 years of age. This one-story building has an irregular rectangular footprint, and gable roof, covered in composite shingles. The window type is similar throughout, comprised of single, aluminum-frame sliders and aluminum frame Chicago style windows. A brick water table extends along the primary elevation.

The primary south elevation is asymmetrical and divided into two bays. The east bay is comprised of the front entrance, a wood door with metal screen. Adjacent to the primary entrance is a single aluminum-frame slider window. An aluminum-frame Chicago style window punctuates the east end. The west bay projects from the building and is punctuated with aluminum-frame slider windows on the south and west end. A covered carport is attached to the east end of the building.

The west elevation is punctuated by a series of four, aluminum-frame slider windows.

This building is not fifty years of age and as such does not appear to be eligible for the California Register and is therefore not considered a historic resource under CEQA.

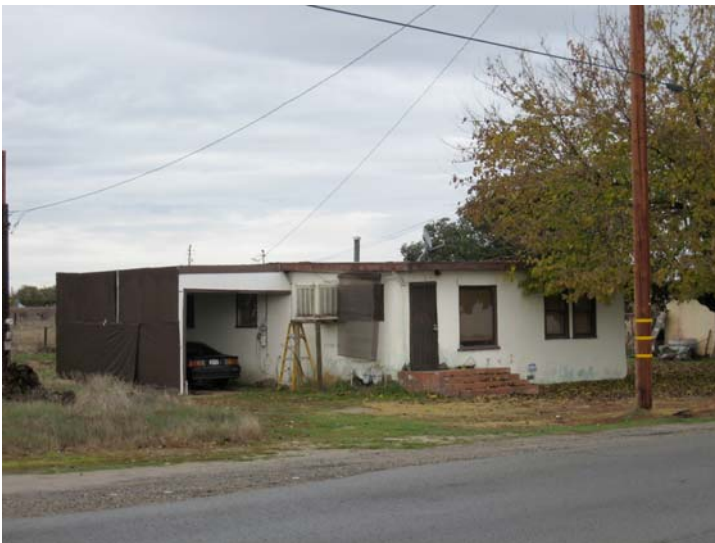
8480 East Floral Avenue. Photo courtesy of Johnson Architecture, December 2009.

The residence at 8480 East Floral Avenue was built in approximately 1950. The one-story building has a square footprint and a flat roof sheathed in composite material. The exterior elevations are covered with stucco applied with the spray technique. The fenestration type is comprised of wood-frame, double-hung, sash and wood-frame fixed windows.

The main entrance, a wood door with metal gate is located along the primary south elevation. The front entry is accessed by a series of brick stairs. Directly adjacent to the

main entrance is a large, wood-frame, fixed window. A pair of wood-frame, double-hung sash punctuates the east end of the elevation.

Two, wood-frame, double-hung sash windows punctuate the west elevation. A carport with a flat roof extends from this elevation.

A clear view of the east elevation was obstructed by plant growth and an exterior screen attached to the wall. However, it appears that a window punctuates the south side of the east elevation, located beneath the exterior screen.

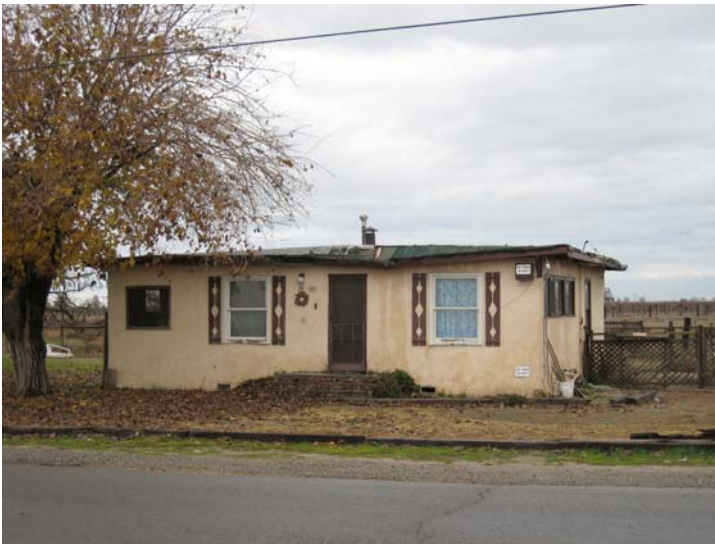
8488 East Floral Avenue. Photo courtesy of Johnson Architecture, December 2009.

The residence at 8488 East Floral Avenue was built in approximately 1950. The one-story building has a square footprint and a flat roof sheathed in composite material. The exterior elevations are covered with stucco applied with the spray technique. The

fenestration type is comprised of wood-frame, double-hung, sash and wood-frame fixed windows.

The primary entrance is centrally located along the main (south) elevation and approached by a concrete step. The entrance is composed of a single wood door with wood-frame screen door. Single, wood-frame, double-hung sash flank the main entrance. A wood-frame, fixed window punctuates the west end of the south elevation.

The south and east end of the east elevation are punctuated by a series of wood-frame, slider windows. A single, wood-frame, double-hung sash is adjacent to the series of slider windows.

A clear view of the west elevation was obstructed by plant growth and debris. However, it appears that a large, wood-frame, slider window punctuates the west elevation.

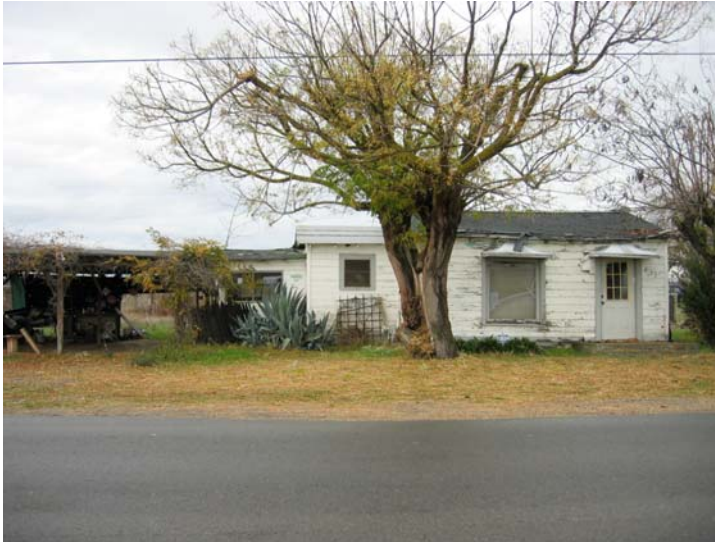
8450 East Floral Avenue. Photo courtesy of Johnson Architecture, December 2009.

The residence located at 8450 E. Floral Avenue was built in approximately 1940. This one-story structure has a compound plan, irregular footprint, and an asymmetrical gable roof, sheathed in composite shingles. The walls are clad in drop siding. The window type is comprised of single, wood-frame, double-hung sash, and wood-frame fixed windows.

The principal residential entry is centrally located on the south elevation. The entryway is comprised of a multi-light, wood door with hood. A large, wood-frame fixed window with hood is located west of the door.

The east elevation is comprised of a series of three, single, wood-frame, double-hung sash.

The west elevation is divided into three bays. The primary south bay is punctuated with a single, wood-frame, double-hung sash. The central bay projects from the building, this

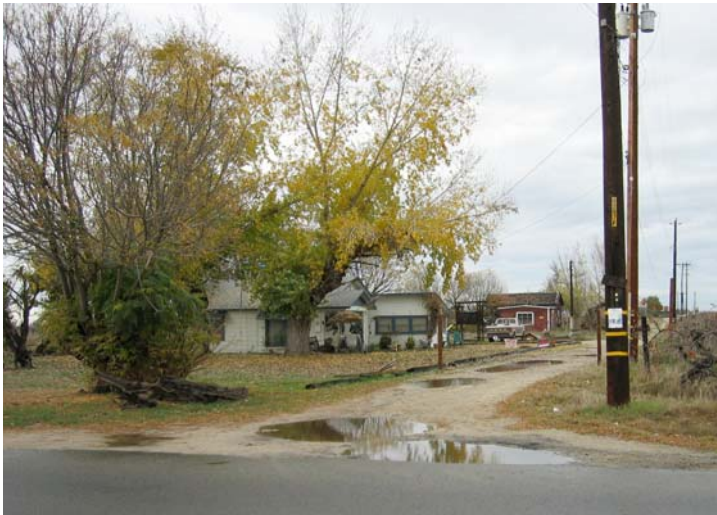
8470 and 8474 East Floral Avenue. Photo courtesy of Johnson Architecture, December 2009.

These structures are primarily obscured from view due to limited access. This description is based on the features that were visible at the time of the site visit.

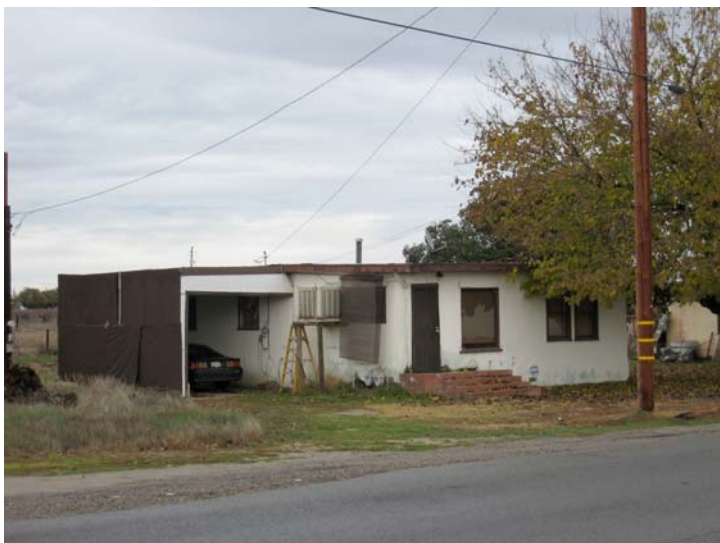
***P5b Photo date:** December 2009

The subject parcel was developed with the single-story dwelling identified as 8480 E. Floral Avenue c. 1950. An incremental review of Selma City Directories from 1923 to 1960. No information was found on any of the current or past owners of the property that would indicate that any of the individuals were important persons in local, state, regional, or national history.

The building has suffered a loss of integrity; the location, setting, workmanship, feeling, and association appear to be unchanged. However, design and materials have undergone significant alterations and deterioration.

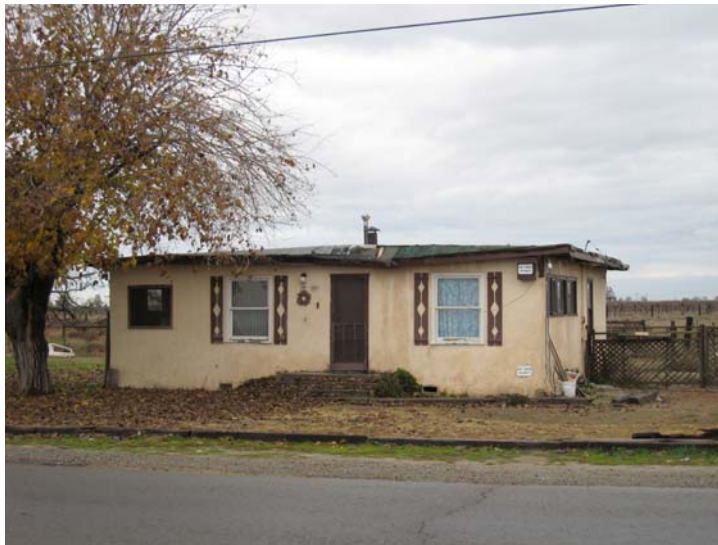
P5b Photo date: December 2009

The subject parcel was developed with the single-story dwelling identified as 8488 E. Floral Avenue c. 1950. An incremental review of Selma City Directories from 1923 to 1960. No information was found on any of the current or past owners of the property that would indicate that any of the individuals were important persons in local, state, regional, or national history.

The building has suffered a loss of integrity; the location, design, setting, workmanship, feeling, and association appear to be unchanged. However, design and materials have undergone significant alterations and deterioration.

The property at 8488 E. Floral Ave. does not qualify to be individually eligible for inclusion on the National Register of Historic Places or the California Register of Historical Resources. Overall, the building appears to be in poor exterior condition.

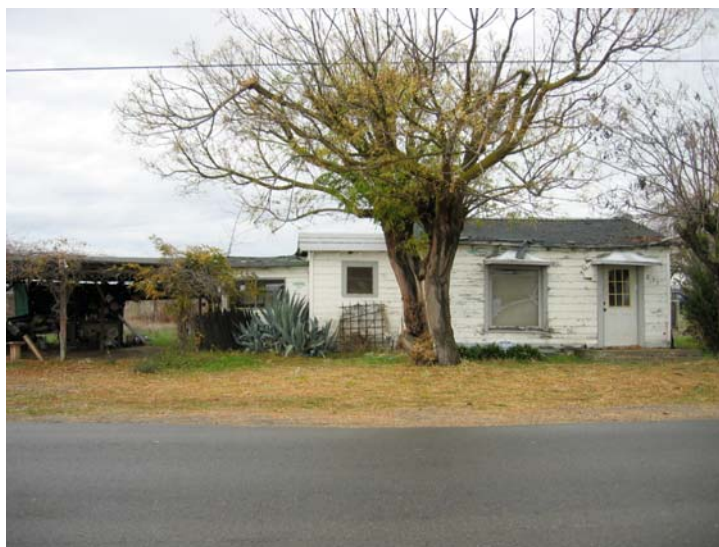
P5b Photo date: December 2009

The subject parcel was developed with the single-story dwelling identified as 8450 E. Floral Avenue c. 1940. An incremental review of Selma City Directories from 1923 to 1960. No information was found on any of the current or past owners of the property that would indicate that any of the individuals were important persons in local, state, regional, or national history.

The building has suffered a loss of integrity; the location, design, setting, workmanship, feeling, and association appear to be unchanged. However, design and materials have undergone significant alterations and deterioration.

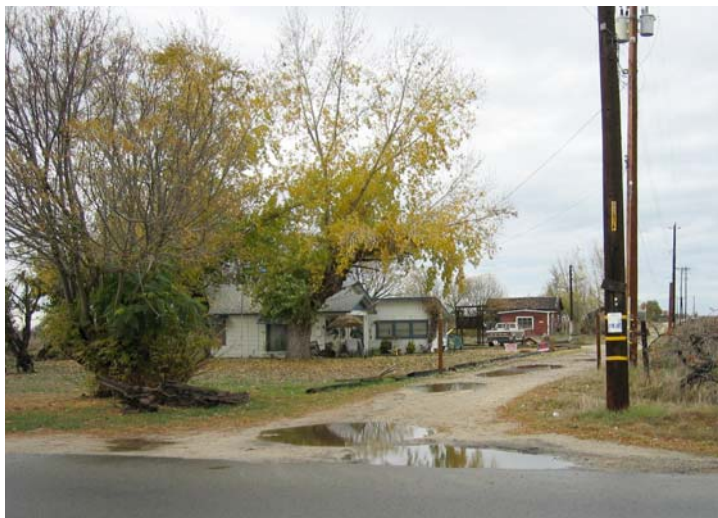
***P5b Photo date:** December 2009

The subject parcel was developed with the single-story dwellings identified as 8470 E. Floral Avenue c. 1940. An incremental review of Selma City Directories from 1923 to 1960. No information was found on any of the current or past owners of the property that would indicate that any of the individuals were important persons in local, state, regional, or national history.

The building has suffered a loss of integrity; the location, design, setting, workmanship, feeling, and association appear to be unchanged. However, design and materials have undergone significant alterations and deterioration.
